Manhole Inspection Summary

Manhole # S11UU_008MH

Insp Date: **5/9/07 1:31 PM**

Location Address: **3104 LIBERTY HEIGHTS AVE** Cross Street: **DENNLIN ROAD**

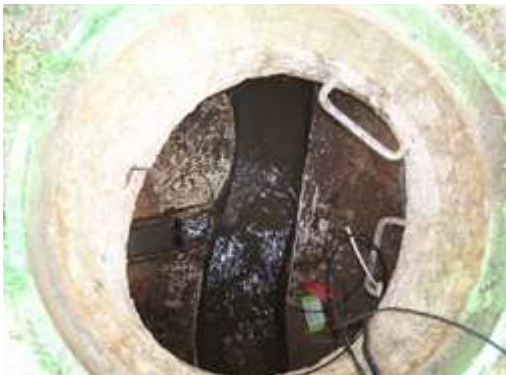
Top View

INCLUDING OVERFLOW @1 O' CLOCK

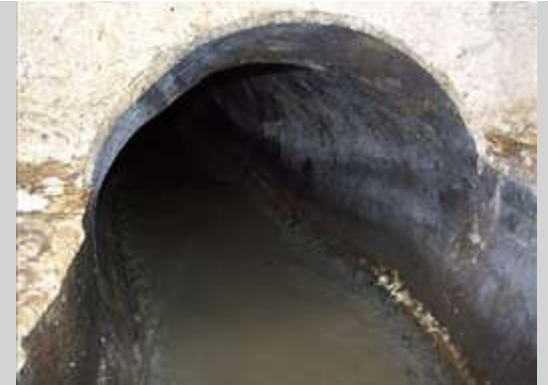
12 O'Clock Outflow

12 in. Circular Gravity Sewer
Pipe Out @ 12 O'Clock

Pipe Height: (in.) Direct
Pipe Material: **PVC** ☐ Pipe Lined
Invert Depth: **7.15** (ft.) Flow Characteristics: **Fast**
Deposits: ☒ None ☐ Mud ☐ Sludge ☐ **Debris** ☐ Grease
Silt Depth: (in.) Deposits Extent:
Infiltration: **None** Pipe Seal Cond: **Sound**

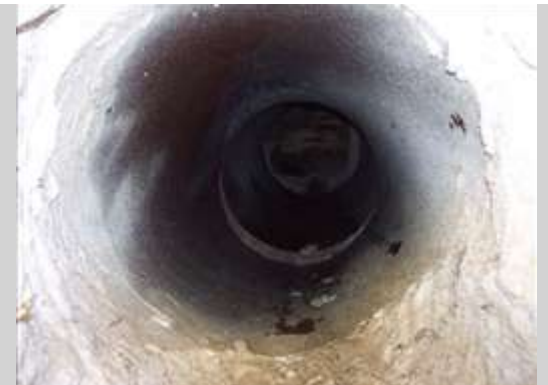
2 O'Clock Outflow

15 in. Circular Gravity Sewer
Pipe Out @ 1 O'Clock

OVERFLOW

Pipe Height: (in.) Direct
Pipe Material: **Concrete** ☐ Pipe Lined
Invert Depth: **5.90** (ft.) Flow Characteristics: **None**
Deposits: ☒ None ☐ Mud ☐ Sludge ☐ **Debris** ☐ Grease
Silt Depth: (in.) Deposits Extent:
Infiltration: **None** Pipe Seal Cond: **Sound**

Connects To: **Connecting Node Not Available**

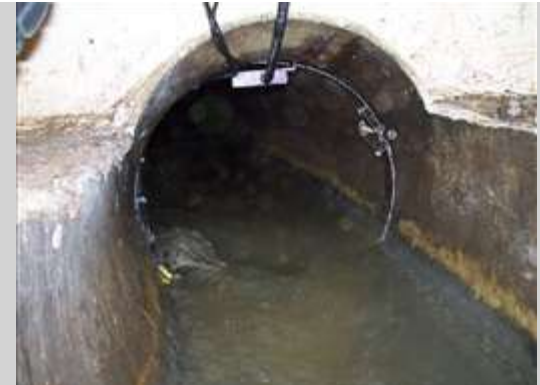
6 O'Clock Inflow

12 in. Circular Gravity Sewer

Pipe In @ 6 O'Clock

Deposits: ☐ None ☐ Mud ☐ Sludge ☒ **Debris** ☐ Grease

Silt Depth: **2** (in.) Deposits Extent: **Light**

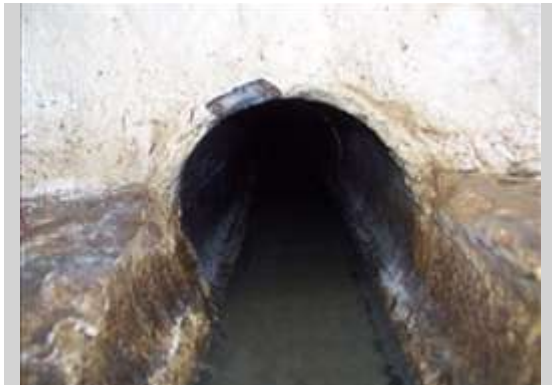
9 O'Clock Inflow

8 in. Circular Gravity Sewer

Pipe In @ 9 O'Clock

Pipe Material: **Clay** ☐ Pipe Lined

Invert Depth: **6.30** (ft.) Flow Characteristics: **Slow**
